Arborist Associates Ltd.

An Arboricultural Assessment on Lands in the Townland of 'Glenamuck North', Kilternan, Dublin 18.

Prepared for: Durkan Carrickmines Developments Limited

Date: 26th January 2026

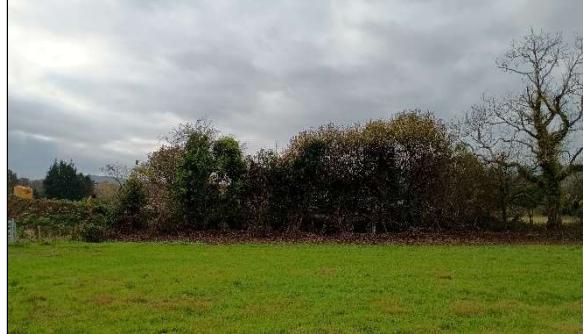
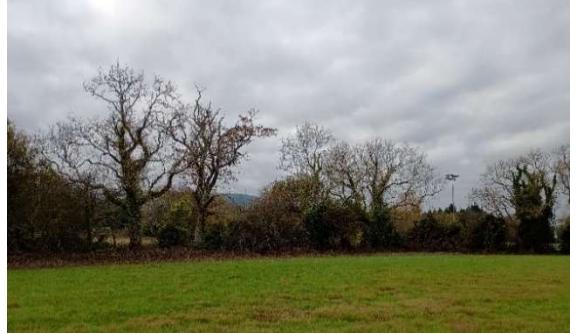
<table border="1" data-bbox="370 1079 774 1151"> <tr> <td>A6</td> <td>--</td> <td>A2E</td> <td>--</td> </tr> </table> <p>It contains the following trees.</p>	A6	--	A2E	--	<p>Control Ivy and Bramble.</p> <p>It would benefit from interplanting with hedge species to improve and thicken structure.</p>	<p>--</p> <p>C2</p> <p>--</p>												
A6	--	A2E	--																	
0861	Ash <i>Fraxinus excelsior</i>	15	800	8	8	7	7	4	Mature	Fair/Poor	Fair	It is a single stem growing on a low bank to the west of a shallow ditch. Ivy growth extends high into the crown. A minor stem at its base on the east side has failed in the past leaving a stump with decay extending back into the main	Retain for now. Make safe dead/ unstable growth.	10+	C2	9.6

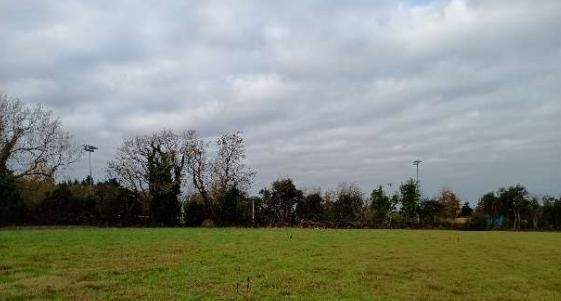
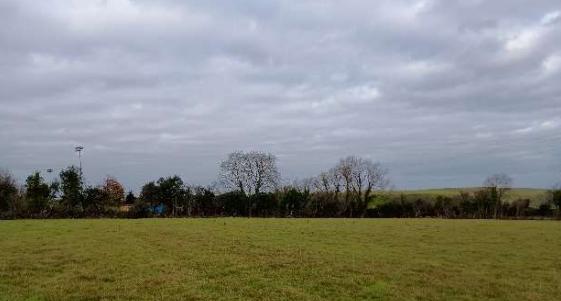
A6 -- A2N A2S --											
				It contains the following trees.											
0864	Ash <i>Fraxinus excelsior</i>	15	600/ 600/ 600/	7	9	4	7	5	Mature	Fair/ Poor	Poor It has grown up with Tree No.0865 with heavy ivy growth extending high into the crown, increasing the wind sail. 'Ash Dieback' is evident in its crown. I suspect ground levels have been altered on the north side as part of the playing field development works which may have impacted the root zone on the north side of the tree. It divides at its base into three stems with an acute union formations between the stems and there is significant decay which may lead to structural failure in the future.	I would recommend its <u>removal</u> as part of management.	<10	U	12.47

0865	Ash <i>Fraxinus excelsior</i>	16	500/ 500	6	12	6	6	4	Mature	Fair/ Poor	Poor It divides near the base into two stems. It has grown up with Tree No.0864 with light ivy growth extending up the main stems. Its crown is weighed out to the south with deadwood throughout, I suspect as a result of infection by 'Ash Dieback'. It is splitting apart at its base	I would recommend its <u>removal</u> as part of management.	<10	U	8.48

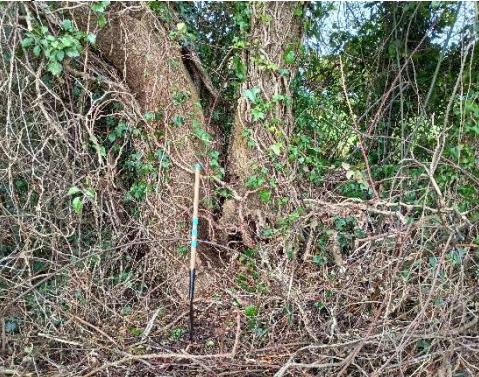
0866	Ash <i>Fraxinus excelsior</i>	20	400/ 500/ 250/ 350/ 600	7	10	9	9	6	Mature	Fair	Fair It is a large, multiple-stemmed tree from near base. Its crown shows early signs of infection by 'Ash Dieback Disease' (<i>Hymenoscyphus fraxineus</i>) with deadwood, branch stubs and dieback present. There are decay pockets developing in some of its branches. There are signs of recent cutting of its lower crown on the south side leaving branch stubs. Light Ivy growth is beginning to develop on its main stem.	Make safe large size dead/unstable growth. Retain for now as part of the bulking of this area. Review again in twelve months.	10+	C2	11.73

0867	Ash <i>Fraxinus excelsior</i>	20	800/ 800	9	10	4	6	7	Mature	Fair/ Poor	Fair It is a twin stem tree from near the base, it shares a canopy with Tree Nos. 0868 and 0869, that have grown up together. Heavy Ivy growth has been controlled. There is deadwood in its crown and there is evidence of infection by 'Ash Dieback' through its crown.	Retain for now as part of the bulking of this area. Review again in twelve months.	10+	C2	13.58
0868	Ash <i>Fraxinus excelsior</i>	22	540	9	10	2	4	7	Mature	Fair	Fair	Make safe large size dead/unstable growth.	10+	C2	6.48

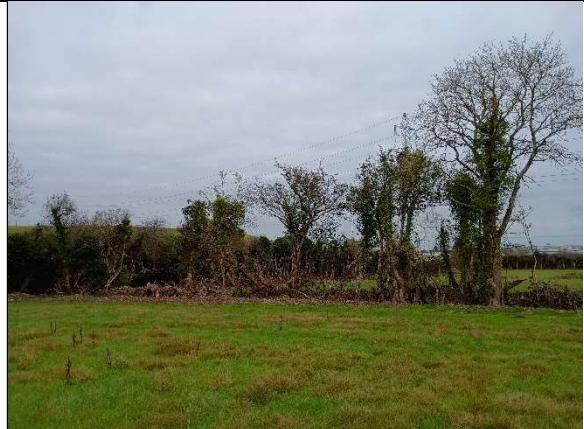
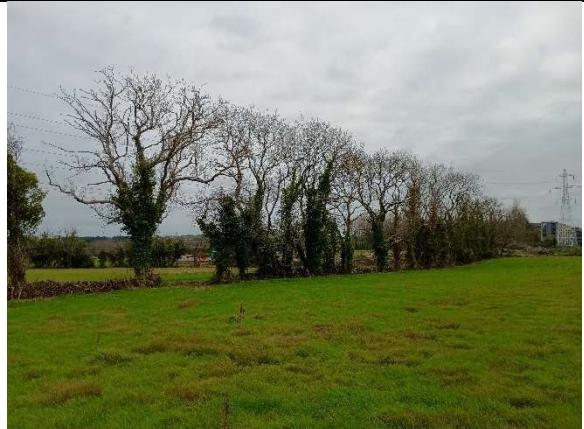
A7	--	A2E	A2W	--							
				It contains the following trees.											
0870	Ash <i>Fraxinus excelsior</i>	13	440/ 400	5	4	5	5	4	Early Mature	Fair/ Poor	Fair/ Poor It was originally a multiple-stemmed from base, two stems have been cut away and its lower crown has recently been pruned. Its crown is showing signs of infection by 'Ash Dieback Disease' (<i>Hymenoscyphus fraxineus</i>) with deadwood and dieback present.	Retain for now as part of the bulking of this area. Review again in twelve months in particular for progression of 'Ash Dieback'.	10+	C2	7.13

0871	Ash <i>Fraxinus excelsior</i>	13	560	5	6	5	6	4	Early Mature	Poor	Fair/ Poor It is a single stem tree with minor stems recently cut away at the base. It is growing on a low bank on the east side of a shallow ditch. Its crown is showing signs of infection by 'Ash Dieback Disease' (<i>Hymenoscyphus fraxineus</i>) with deadwood and dieback throughout. Heavy	It will need to be <u>removed</u> in the short term as part of management.	<10	U	6.72

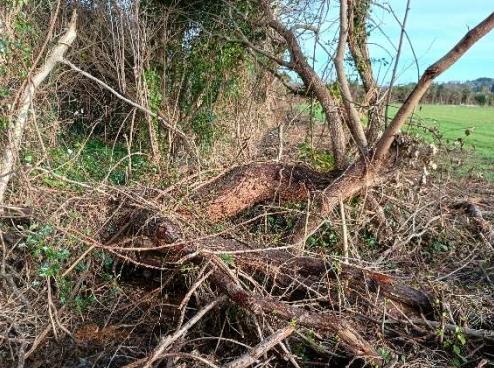
Cut/ coppice into the hedge and allow to sprout to form part of the hedge bulking.	<10	U	7.2
0891	Ash <i>Fraxinus excelsior</i>	13	530	4	6	7	6	5	Early Mature	Fair	Fair/ Poor It is a single stem tree growing on top of a low stonewall. Part of the crown has collapsed on the north side. There are broken branches / stubs in its lower crown on the south side. Ivy growth extends up into the crown, increasing the wind sail.	Cut ivy at ground level. Remove collapsed stems. Prune broken branches /stubs to target pruning points. Review again in twelve months.	10+	C1	6.36

0892	Ash <i>Fraxinus excelsior</i>	8	400	1	1	1	1	2	Early Mature	Fair/ Poor	Poor It has been cut down to clear adjacent overhead power lines. It is regrowing from the cut points and has a small compact crown at present. It will require ongoing cutting to	I would recommend its <u>removal</u> due to overhead utility lines as part of management.	<10	U	4.8

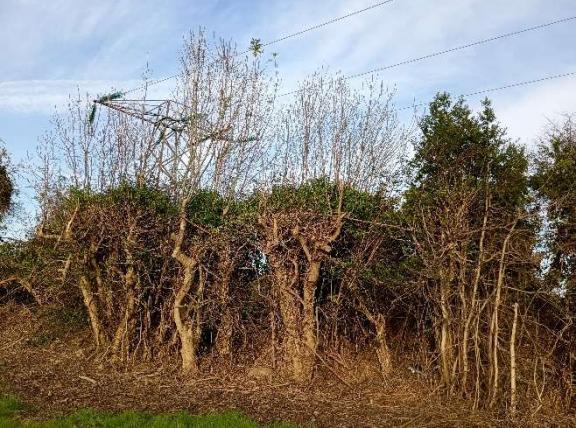
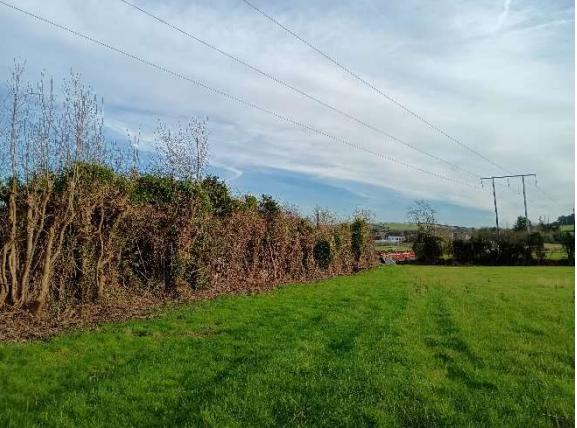
A8	--	2E	2W	--							
Hedge No.6	Ash <i>Fraxinus excelsior</i> Holly <i>Ilex aquifolium</i>			<p>It extends at ninety degrees from Hedge no. 5 in a broadly east to west direction.</p> <p>It is of a mature age class in fair condition physiologically and fair/ poor condition structurally. There is a small stream flowing along the northern side of the hedge. The western end of the hedge has trees on both sides of the stream forming a double row. The hedge has been cut down at the eastern end to clear the overhead powerlines at this location. It has been allowed to grow in an unmanaged manner and the undergrowth has recently been cleared, mainly on the north side, leaving the trees.</p>				<p>It requires no work at the present time.</p>				--	C2	--

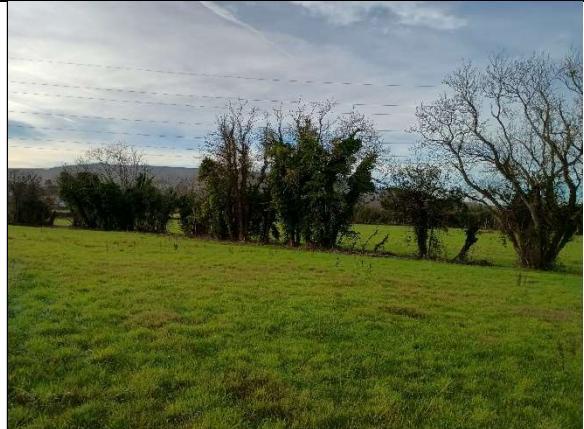
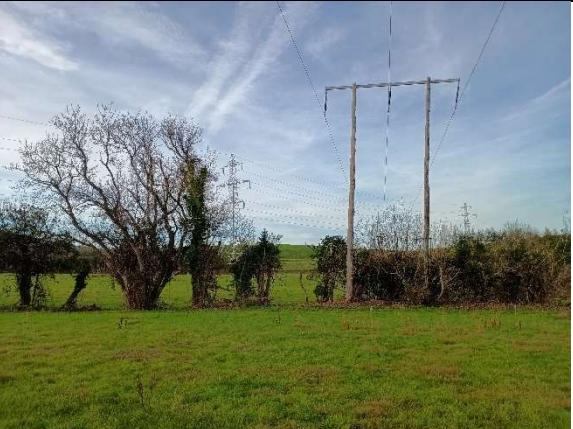
A6	--	2N 3S	--								
				It contains the following trees											
0894	Ash <i>Fraxinus excelsior</i>	12	320/ 130/ 320/ 340 4 stems	5	5	6	1	4	Early Mature	Poor	Poor It is multiple-stemmed from near base with heavy undergrowth of Holly, Sycamore and Bramble around the base. Significant excavations have taken place in the root protection area of the tree, c.1m off the base on the west side and part of the south side, impacting the root zone and severing roots. It has been infected with 'Ash Dieback Disease' (<i>Hymenoscyphus fraxineus</i>) with dieback evident in the crown. It has no potential.	I would recommend its <u>removal</u> as part of management.	<10	U	9.97

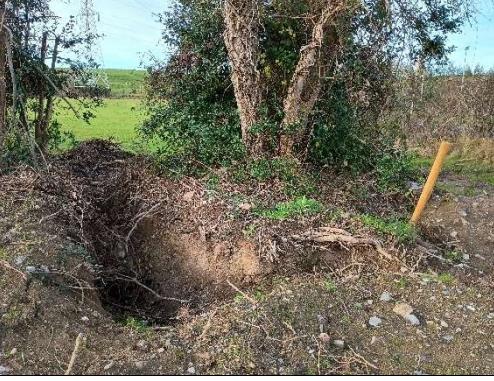
0895	Ash <i>Fraxinus excelsior</i>	13	520/400	6	4	3	3	4	Mature	Fair/Poor	Poor It divides near base into two stems. The east stem has been cut back due to overhead cable at c.6m with regrowth developing from the broken point. Heavy Ivy extends high into its crown, increasing the wind sail. It is being suppressed by the larger Tree No. 0896 to the west. It has been infected by 'Ash Dieback Disease' (<i>Hymenoscyphus fraxineus</i>) with minor dieback evident in the crown.	Retain for now as part of the bulking of this area. Review again in twelve months for impact of 'Ash Dieback'.	10+	C2	7.87

0896	Ash <i>Fraxinus excelsior</i>	15	A320 x 8 stems	5	7	5	9	5	Mature	Fair	Fair/ Poor It is multiple-stemmed from base with acute union formations between the stems. Heavy Ivy growth has been controlled. It has been infected with 'Ash Dieback Disease' (<i>Hymenoscyphus fraxineus</i>) with deadwood and dieback throughout.	Retain for now as part of the bulking of this area. Review again in twelve months for impact of 'Ash Dieback'.	10+	C2	10.86
0897	Holly <i>Ilex aquifolium</i>	8	260 x 3 stems	3	3	5	2	5	Early Mature	Fair	Fair It is multiple-stemmed from near base with a very acute union formation between stems. Heavy Ivy cover extends up into the crown. It	Prune damaged stubs to target pruning points.	10-20	C2	5.4

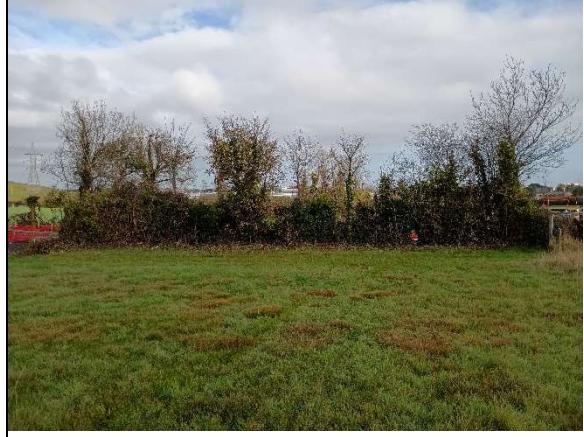
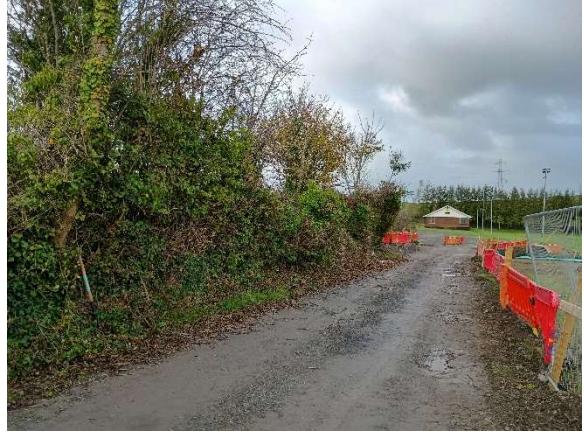
Hedge No.7	Ash <i>Fraxinus excelsior</i> Holly <i>Ilex aquifolium</i> Hawthorn <i>Crataegus monogyna</i> Sycamore <i>Acer pseudoplatanus</i>	<p>It extends at ninety degrees from Hedge no. 6 at the southern end of Hedge No.5 in a broadly north to south direction along the eastern boundary of the site area.</p> <p>It is of a mature age class in fair condition physiologically and fair/ poor condition structurally. It has been allowed to grow in an unmanaged manner and consists mainly of young, sapling Ash and Sycamore trees starting to develop above an understorey of Holly and Hawthorn. Ivy and Bramble are colonising the line. It has been cut recently on the eastern side to maintain clearance over the adjacent roadway and a central section has been removed for the road reservation creating a break in the hedge and the section of hedge south of break is of the better quality.</p>

<p>It requires no work at the present time.</p>				--	C2	--
